Naval Surface Warfare Center Carderock Division

NSWCCD-65-TR-2003/38 September 2003

SIDER Testing of a Damaged Section of Mast from the *Mirabella V* Superyacht

Colin P. Ratcliffe, *United States Naval Academy*

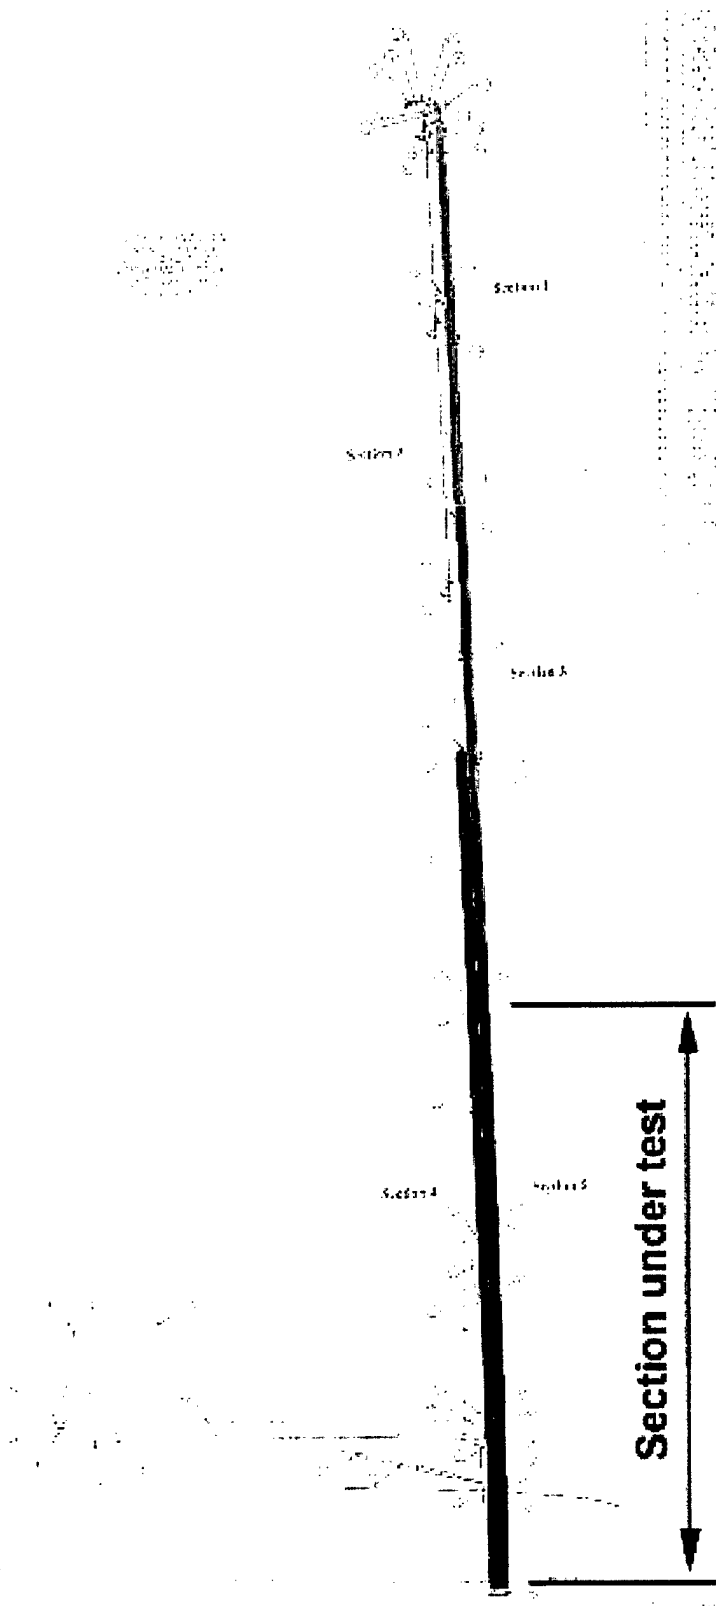
Figure 3. Drawing Showing the Section of the Mast that Was SIDER Tested

This report presents the results of a single Structural Irregularity and Damage Evaluation Routine (SIDER) inspection of one section of the new mast of the *Mirabella V* superyacht. The section that was tested had known manufacturing defects. Prior to the SIDER testing, the decision had been made by VT Halmatic Limited, Portchester Shipyard, Hamilton Road, Portsmouth, UK to remake the component. Therefore, the work reported here was conducted on a structurally unacceptable component that was not going to be used in service.

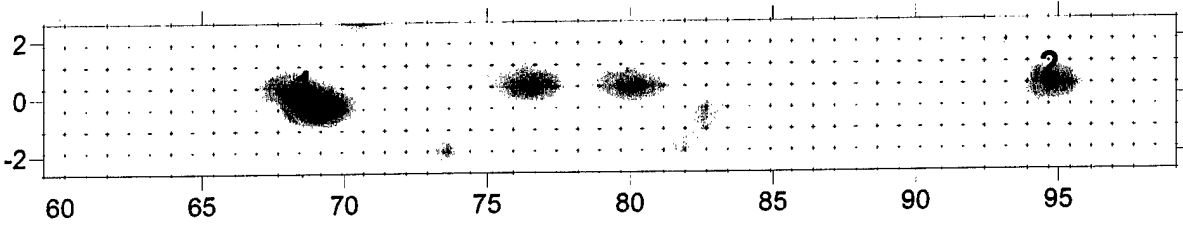
Figure 9. SIDER Contour Plot

Figure 9 shows the SIDER contour plot. On this plot, the small crosses show the test grid and the axes legends show the distance in feet from the global origin. While SIDER is a directional test, the results shown here are solely for the up-down analysis. The analysis requires a reasonably large number of test points in the direction of the analysis. For this specific test, it was decided to limit the interest to the up-down analysis, and therefore the test grid was

There were two major features identified on the mast section, indicated by locations 1 and 2 on Figures 9. For location 1, there was a noticeable surface indication or bulge. The SIDER results correlated closely to what was visually seen on the inner surface. Although the damage was visible from the inside, there was no indication on the exterior of the mast. Since the testing was performed on the exterior, the significance of locating this anomaly from the exterior is noteworthy.

with that determined using the laser shearography. In addition, the regions between 75 and 80 shown in Figure 9, which were also inspected using laser shearography also correlated well with the SIDER results. It should be noted that the SIDER indication shows that these latter areas were not as severe as locations 1 and 2. It is not known whether the laser shearography provide the same conclusions.

Location 2 showed no visible indication on either the interior or exterior of the mast section. The significance of this indication, however, was of the same magnitude as location 1 as seen by the intensity of the red color. The SIDER results are such that the larger the value, the more severe the anomaly. No further investigation was performed to try to determine the specific type of damage that was present.
